PROFESSIONAL RESERVE STUDY

Heritage Park

3208 - 52nd Place NE, Tacoma, WA 98422

May 28, 2019

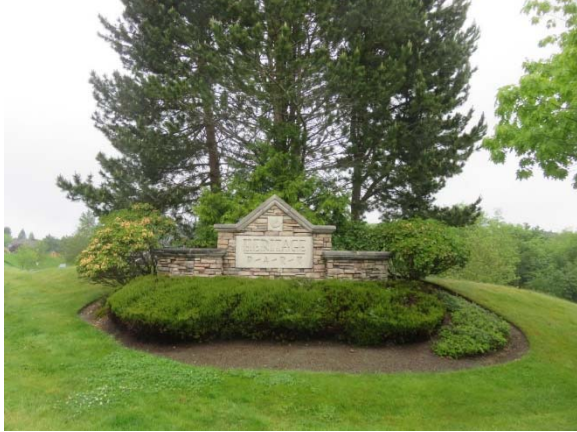
There are entrance monuments at the two entrances to Heritage Park. The monuments will require a small amount of maintenance in the form of cleaning, painting, sealing, and tuck-pointing of the masonry. This level of maintenance has been scheduled every 10 years.

West Entrance Monument

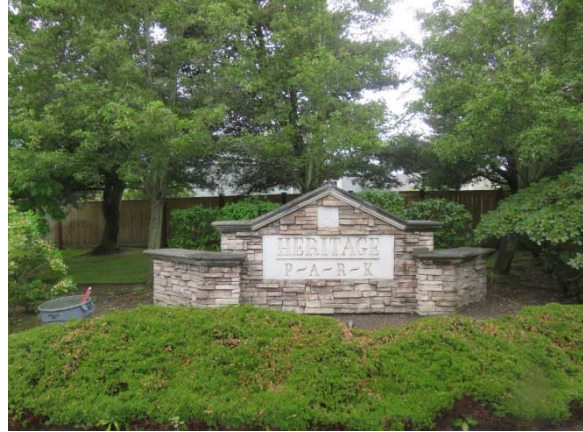
South Entrance Monument

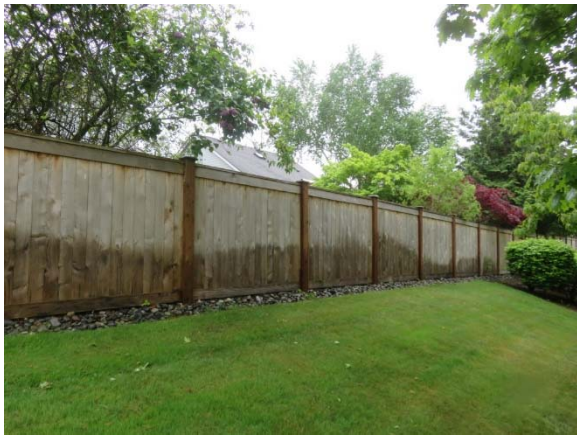
The homeowners association is responsible for the maintenance and eventual replacement of the common wood fencing on both sides of the south boulevard near at the south entrance to this property. We understand that this wood fencing was recently replaced in 2018. This fence should have a total lifespan of 25 years if it is maintained by staining and spot replacement every 5 years.

Common Fencing

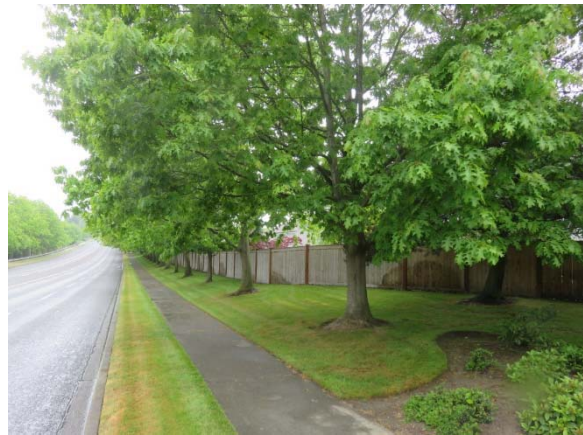
We understand that the fencing along the city streets on the perimeter of this property is not the responsibility of the HOA.

Municipally Owned Fencing

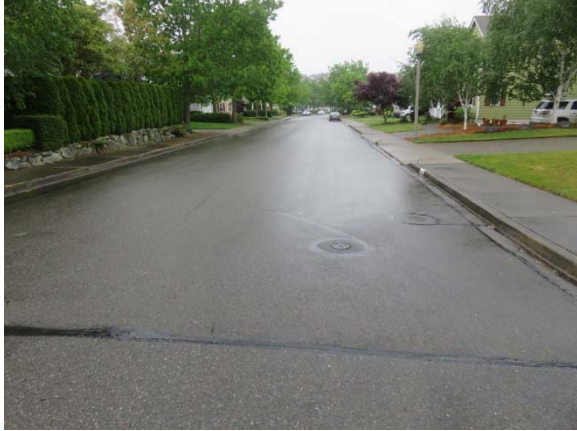
All of the streets in this development are public and are not maintained via the homeowners association. However, the HOA is responsible for the maintenance and eventual replacement of the asphalt walking paths in the community park. As this walking path will not receive any vehicle traffic, we have assumed that the asphalt walking paths will have a 40-year service life before an asphalt overlay is necessary.

Typical Public Street

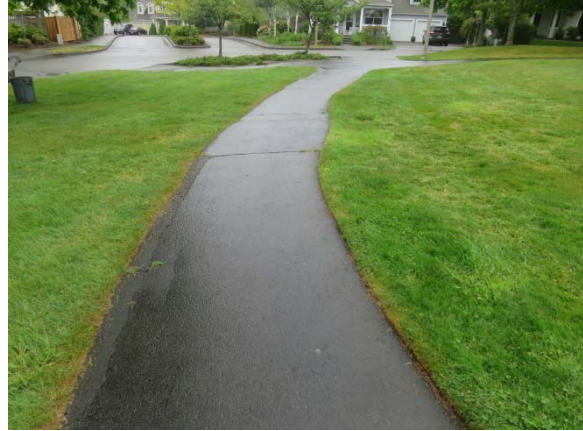
Asphalt Walking Path in Park

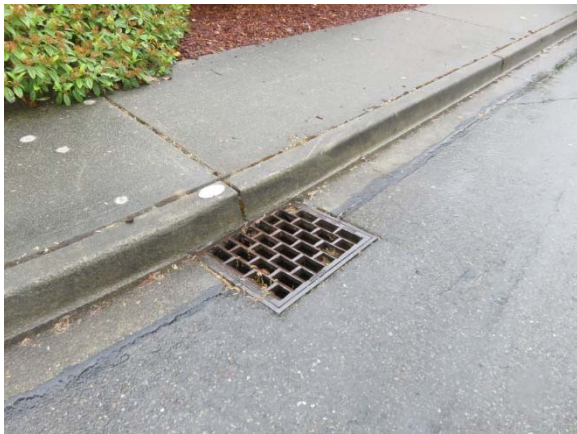
The storm system on this property is public and is not maintained via the homeowners association.

Typical Storm Drain

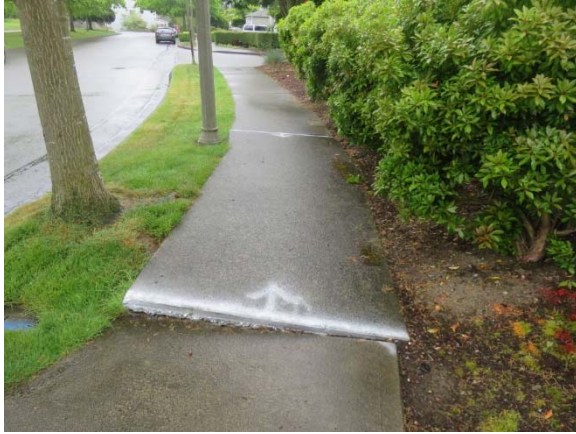
The concrete sidewalks and square concrete curbing that are adjacent the roads within the development are maintained by the homeowners association, while the sidewalks along the main roads outside of this development are municipally maintained. There are currently concrete sidewalk repairs that are necessary. We have assumed that a similar level of concrete sidewalk maintenance will be necessary every 5 years.

Sidewalk in Need of Repair

Component	Cost	Urgency	Section
Concrete sidewalk repairs	\$10,000	2019	3.2

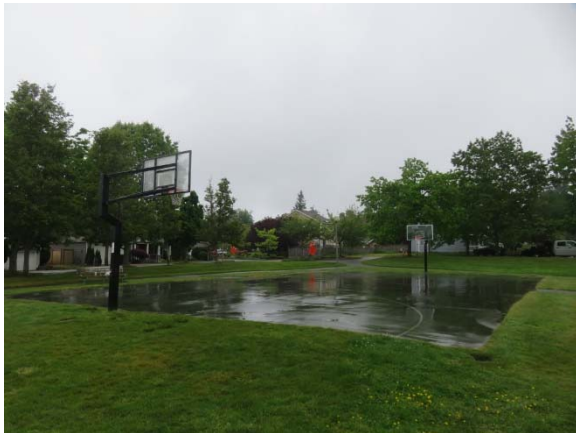
There is a basketball court in the common park. We have budgeted for resurfacing of the basketball court every 20 years and replacement of the backboard assemblies every 10 years. However, this duration could vary up or down depending on the quantity of use and care that is taken.

Basketball Court

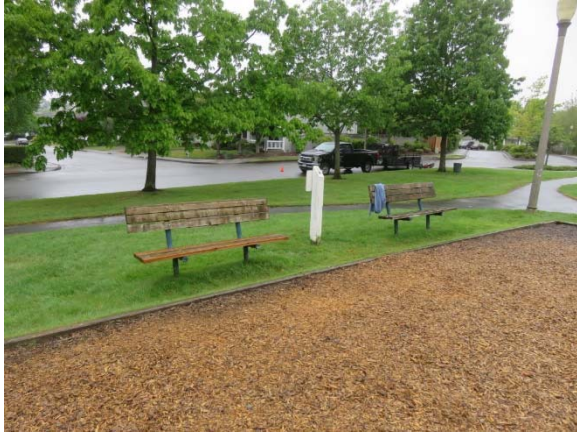
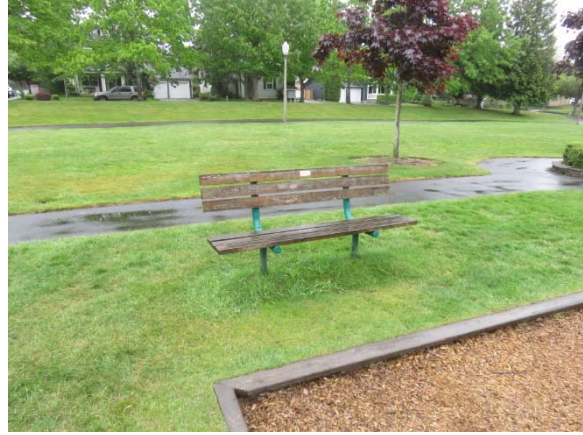
There are picnic tables and benches in the common park. Rather than budget for each bench to be replaced, we have simply budgeted for a small allotment for replacement of some of this equipment as necessary every 10 years.

Typical Park Benches

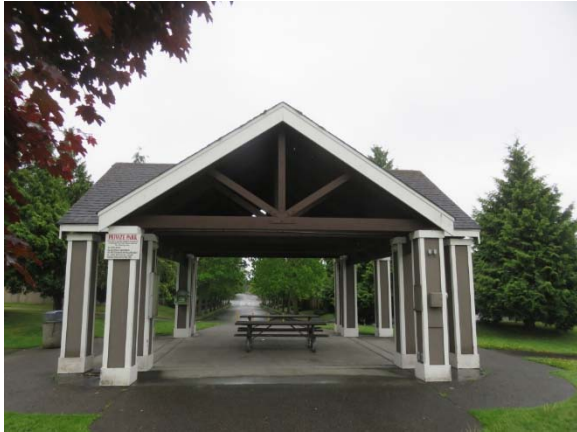
There is a pergola in the common park. This pergola is relatively simple. We have assumed that the structure and cladding of this pergola will have a lifespan beyond the duration of this study if maintained by paint and stain. We understand that the homeowners themselves periodically paint the pergola and that no Reserve Funding will be used to paint this structure. We have included in the Reserve Study the cost to resurface the roof of this pergola every 30 years as the roof surfacing has a 30-year nominal service life.

We understand that this pergola was hit by a vehicle and repaired approximately 5 years ago via an insurance claim.

Pergola

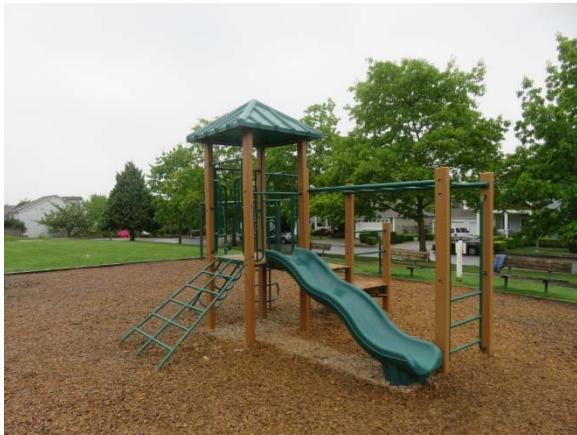
There is a playground structure in the common park that was recently installed in 2016. This playground equipment consists of metal and plastic. We have assumed that minor maintenance of the playground equipment can occur by the residence of this community and that staining can occur via the operating budget. Therefore, we have assumed a total lifespan of 20 years for the playground structure.

We have included the addition of playground chips every 3 years in the Reserve Study and we have done so.

Playground

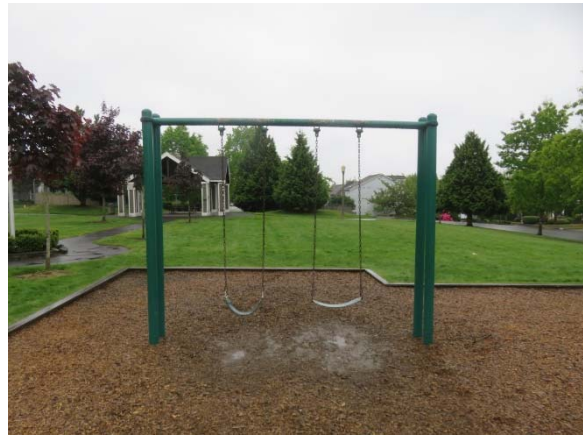
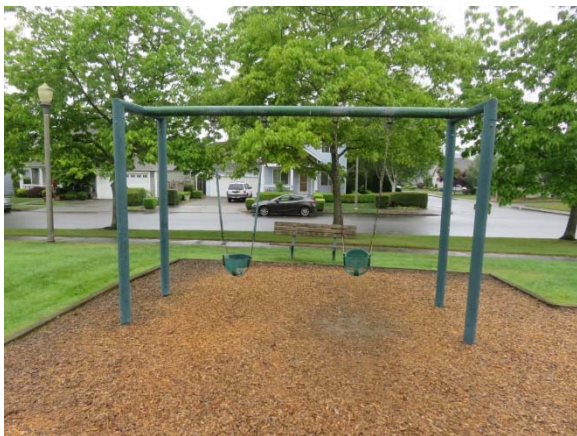
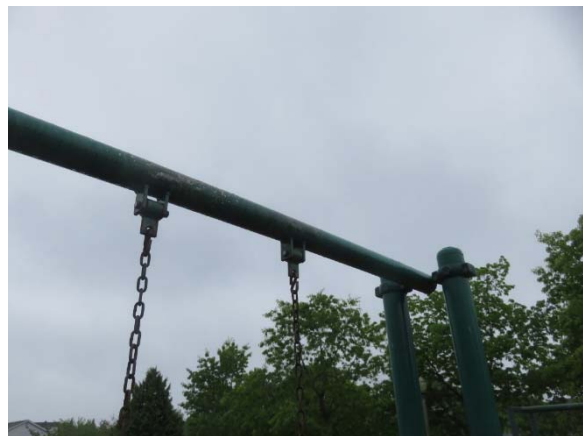
The two swing sets should have a lifespan beyond the duration of this study. Periodically, smaller components of these swing sets will need to be replaced, which are small costs.

One of Two Swing Sets

Two of Two Swing Sets

Close-up of Swing Set Hardware

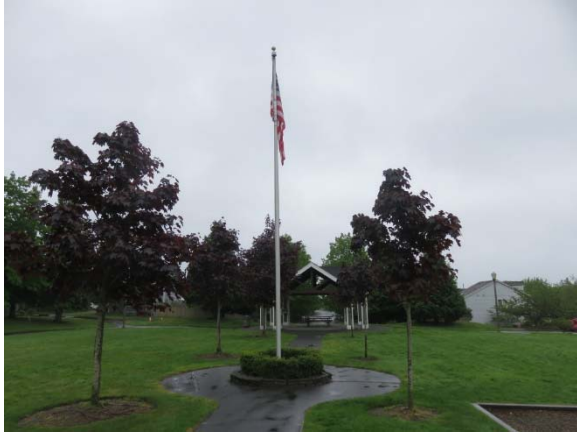
The flag pole in the common park should have a lifespan beyond the duration of this study. The flag will need to be replaced; however, this is relatively inexpensive and is not factored into the Reserve Study.

Flag Pole

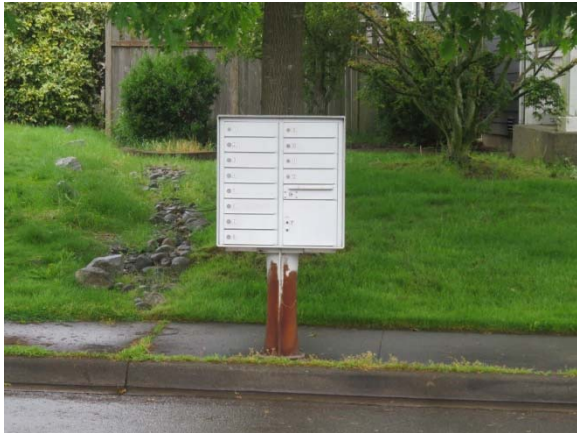
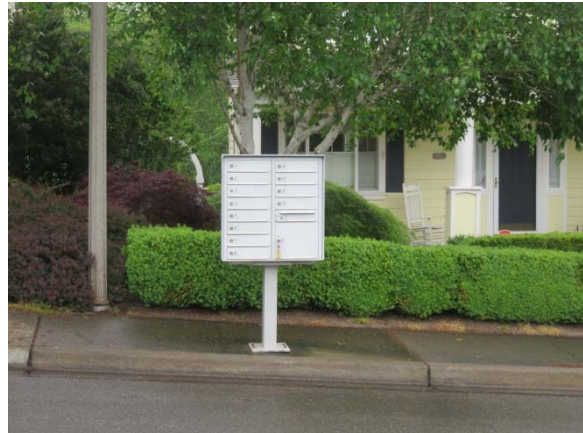
The mailbox kiosks are owned by the United States Post Office and are not the responsibility of the homeowners association.

Typical Mailbox Kiosk

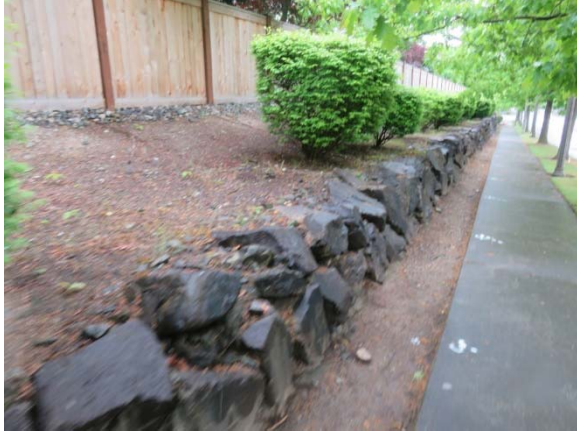
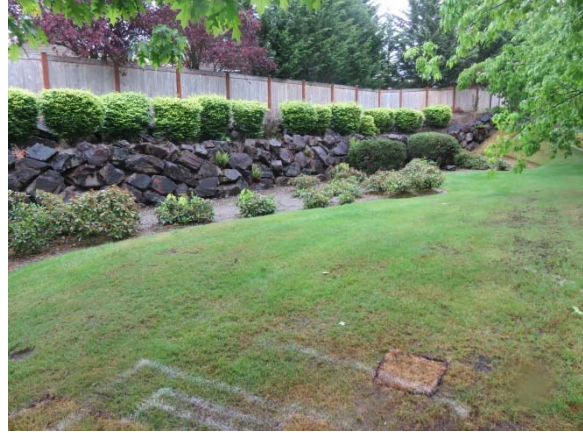
There is a rock wall along the south entrance. This wall should be relatively easy to maintain via the operating budget and landscaping crew if there is rocks that fall out of place. Therefore, no funding has been designated for this rock wall from the Reserve Fund.

Rock Wall

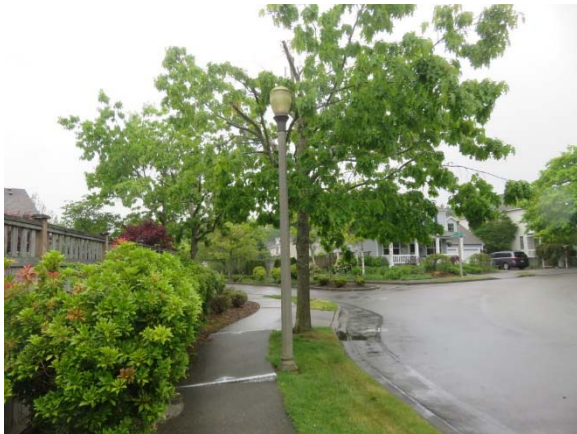
The majority of the concrete lights in this development are located along the streets and are the responsibility of the local municipality. The concrete lights in the park are the responsibility of the homeowners association; however, these lights should have a life span beyond the duration of this study, unless a vehicle hits these lights. In which case, that should be paid for via the offending driver’s insurance. The replacement of the light ballasts should be paid for via the operating budget.

Typical Concrete Light

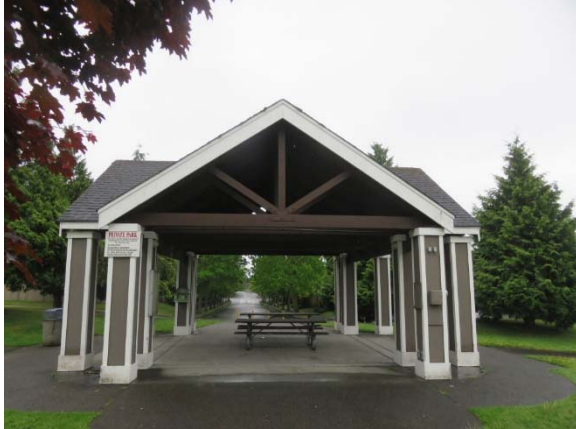
The only common roof surfacing on this property is that of the pergola. We have budgeted to resurface this roof every 30 years as the current roof surface has a nominal lifespan of 30 years.

Roof of Pergola
